**SAS Superstructure**

Location: 04-SF-80-13.2 / 13.9

Daily Diary Report by Bid Item

Today I was tasked with inspecting the trial fit-up between the CCO-200s01 suspender protection brackets & Cable Band (CB) 98. This work was to be done in the pier 7 warehouse.

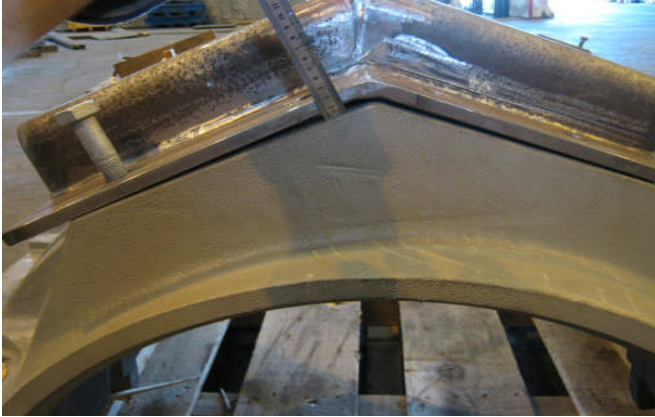
- From 08:30 until 09:00, I walked through the warehouse to check for any ongoing CCO-200s01 work. None was ongoing at the time. However, one of the brackets had been attached to the westbound CB98. This work was probably done on late Friday afternoon or Saturday. The fit of the bracket against the CB was not a tight fit (see attached photo), & it looks like there may be some grinding needed to make it a tight fit. Note 4 on the CCO drawings allow for grinding of the CB to make a tight fit between the bracket & the CB.

Initial fit of protection bracket against CB98 Westbound

- From 14:00 until 15:00, I did misc office work (checked email, updated vehicle mileage log, started my diary for the day, etc).
- From 15:30 until 16:15, I checked at the warehouse again, & no work was ongoing. I spoke with ABF Engineer Ben Jones about the quality of the fit between the bracket & the CB. He said that they plan to tighten the bolts to see if this brings the bracket into better fit, & possibly submit an RFI detailing the issue if the fit does not improve during bolting.
